# GEAR FAILURES

- *how to recognize them*
  - *what causes them*
    - *how to avoid them*

Reprinted from MACHINE DESIGN December 7, 1967  
Copyright 1967 by The Penton Publishing Co., Cleveland, Ohio 44113

## EUGENE E. SHIPLEY

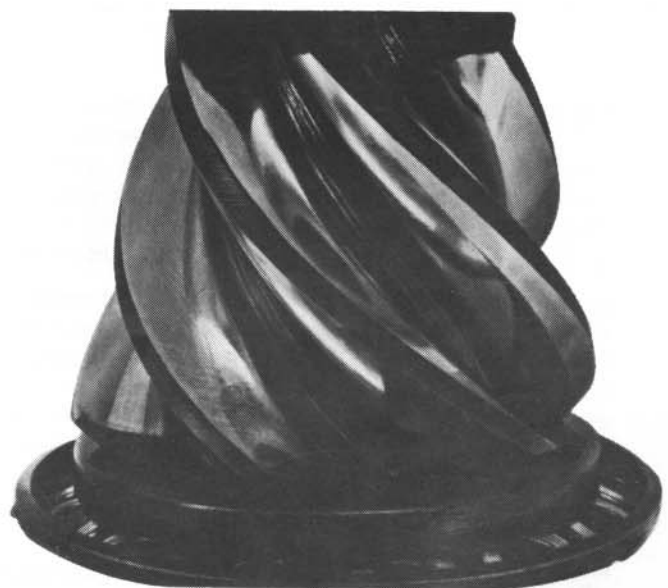
Polishing is a very slow wearing-in process in which the asperities of the contacting surfaces are gradually worn off until a very fine, smooth surface develops.

**Cause:** This condition is usually caused by metal-to-metal contact during operation. Generally, “polishing-in” occurs on slow-speed applications where the elasto-hydrodynamic lubrication film is not sufficiently thick and the gears are operating near the boundary-lubrication regime.

**Polishing:** Run-in under operating conditions, this hardened hypoid pinion has developed a highly polished surface. Undoubtedly the extreme-pressure additives in the lubricant had a tendency to promote polishing on the tooth surfaces.

**Remedy:** Often this condition need not be avoided unless the design life of the equipment is much longer than the predicted wear life based on polishing-in. Polishing gives good conformity of the surfaces.

After the gear is well polished-in, the surface can be protected by substituting a lubricant with a higher viscosity, by reducing the transmitted load substantially, or, in some cases, by increasing the operating speed to obtain a better elasto-hydrodynamic oil film.

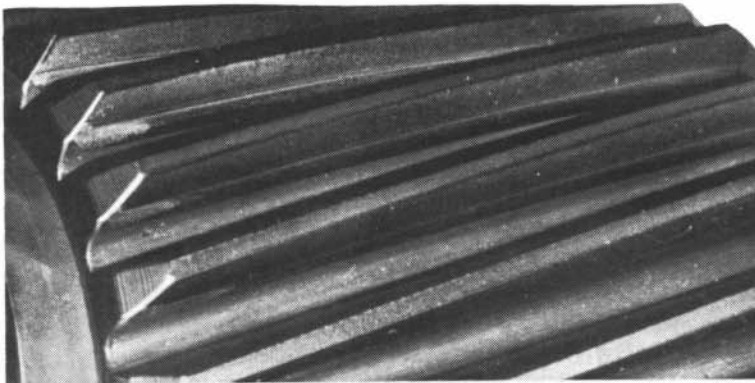
The type of wear classified as moderate takes place over a relatively long period of time. The contact pattern indicates that metal has been removed in the addendum and dedendum area; also, the pitch line begins to show as an unbroken line.

**Cause:** Moderate wear is most commonly caused by an inadequate lubrication film, with the film

**Moderate Wear:** The addendum and dedendum sections of these medium-hard gear teeth have worn, causing the operating pitch line to become visible because little if any material has been removed along this line.

thickness being too thin for the load. Dirt in the lubrication system can also cause this type of wear.

**Remedy:** One solution is to specify a lubricant with a greater film strength, or one with a higher viscosity. Also, the unit can be operated at a greater speed to build up the lubricating film. Finally, a gear material with a higher wear resistance can be specified.

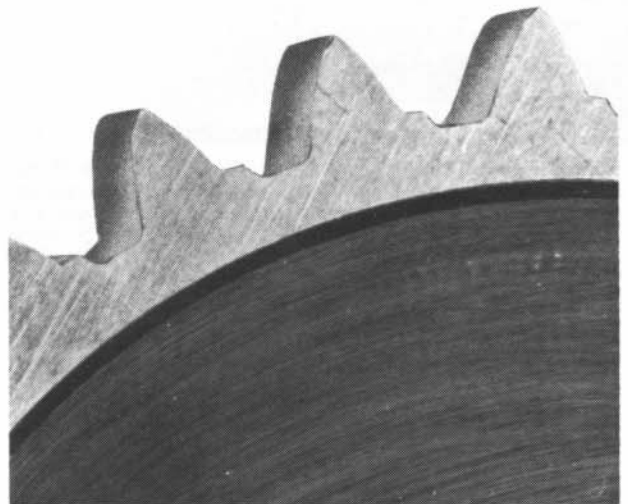
This is simply normal wear which has progressed to the point where a considerable amount of material has been removed from the surfaces. The pitch line is very prominent and may show signs of pitting.

**Cause:** This problem is usually caused by the failure to notice early enough that wear is in prog-

**Excessive Wear:** Material has been uniformly worn away from the tooth surface causing a deep step. The tooth thickness has been decreased and the involute profile destroyed. Some slow-speed gears can operate on such a profile until so much material has been worn away that the tooth fails under beam bending fatigue.

ress. When enough material has been worn from the tooth surface, the involute profiles are destroyed and the gears begin to run roughly. The situation is aggravated by the rough running, causing still

greater wear. Eventually the surface is such that the gears are no longer fit for reliable service.

**Remedy:** This condition could be avoided by using the same methods given for moderate wear—increasing lubricant film strength or viscosity, or increasing pitch-line velocity.

If the gear unit is splash-fed, changing to a positive spray lubrication system with a filter will help keep wear particles out of the gear mesh and ensure that adequate lubricating oil is delivered to the working surfaces.

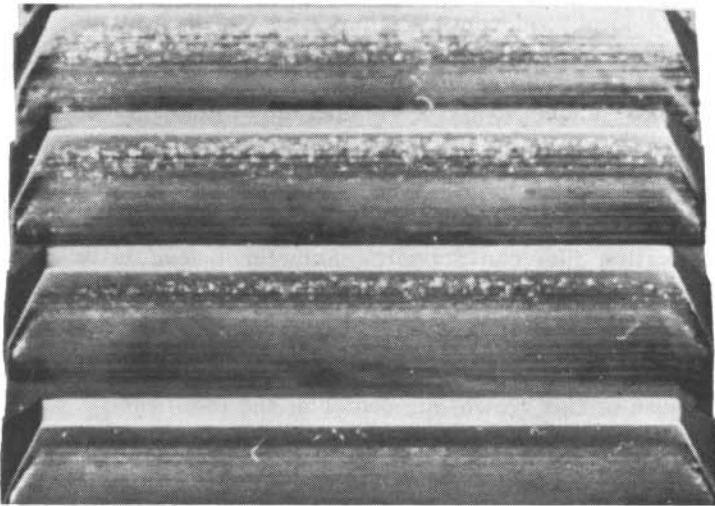
Frosting occurs in the early stages of scoring. Usually the dedendum section of the driving gear is the first to show signs of surface distress, although frosting can first show up on the addendum section.

As the name implies, the wear pattern appears frosted. The normal polish of the surface has an etch-like finish. Under magnification, the surface appears to be a field of very fine micro-pits less

than 0.0001 in. deep. The frosted pattern will sometimes follow the slightly higher ridges caused from cutter marks or other surface undulations.

**Cause:** Frosting is caused by heat in the mesh, which results in only marginal lubrication. The heat of the mesh and the bulk temperature of the rotating gears combine to break down the lubrication film.

**Frosting:** This hardened and ground spur gear shows the early stages of frosting. In this case the addendum portion of the teeth shows the spotty frosting pattern. Damage to this gear is negligible at this stage.

**Remedy:** A very careful break-in cycle is often beneficial. A break-in cycle starting with reduced

speeds and reduced load will condition the gear-tooth surfaces and improve the conformity of the contacting surfaces so that less local heat will be generated because of better load distribution. Reduced oil temperatures or better control of temperature fluctuations will tend to keep the heat level within safe limits. A mild extreme-pressure oil may be helpful but may not be necessary.

Often, where frosting appears, subsequent operation of the unit will slowly polish away the frosted areas if all operating conditions remain constant.

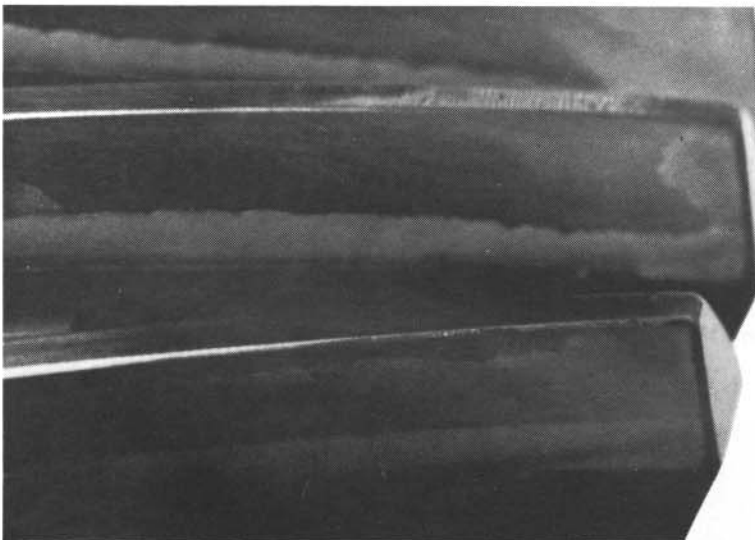
**Frosting:** This hardened helical gear shows a typical frosting pattern. Note that frosting is predominantly in the dedendum section, although patches do appear in the addendum section. This frosting pattern shows no radial welding and tear marks.

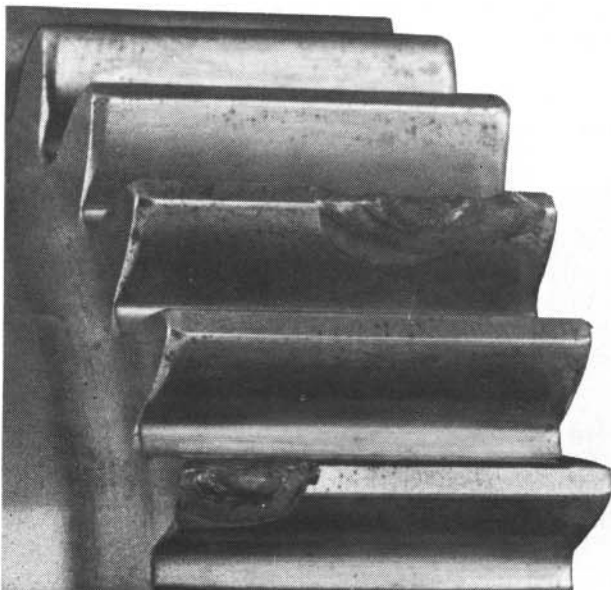
Gear-tooth breakage is usually associated with the root-fillet section of the gear tooth; however,

**Random Fatigue Breaks:** These breaks are not typical beam bending failures. They originate high on the tooth flank and are somewhat uniformly dispersed across the face of the gear. Failures of this nature originate from stress risers other than at the root fillet. In this installation, fatigue failure resulted from grinding cracks on the tooth flanks.

breakage failure can occur in other portions of the gear tooth. Sometimes, the top of a gear tooth will break away or large chips will fatigue away from the end of a tooth.

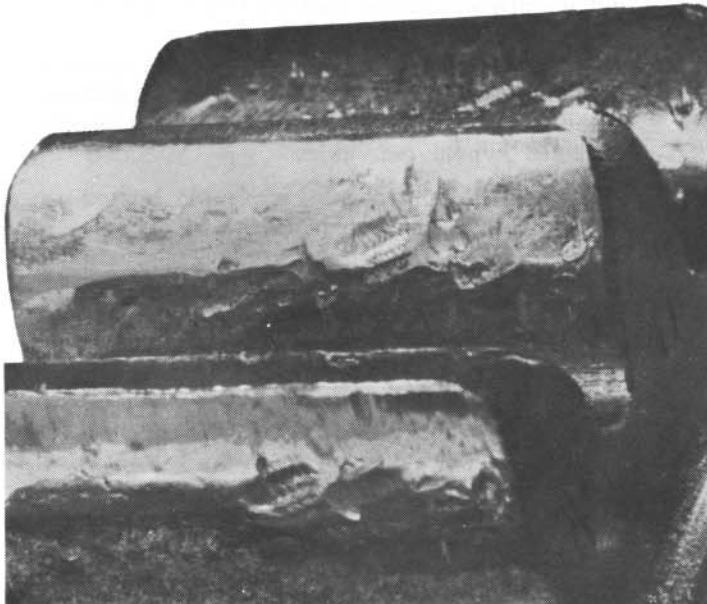
**Cold Flow:** This medium-hard spur gear shows signs of bad surface deformation due to rolling and peening action. This gear was operated long after the initial surface distress occurred, resulting in a battered cold-worked surface.
